**Report: Chilt/RF12065
Revision B**

**A fire resistance test performed on 2No
two single leaf single acting doorsets
with glazing**

**Test conducted in accordance with
BSEN 1634-1:2008 and BSEN 1363-1:
1999**

**Prepared for: Vistamatic Ltd
51-55 Fowler Road
Hainault Industrial Estate
Hainault
Essex
IG6 3XE**

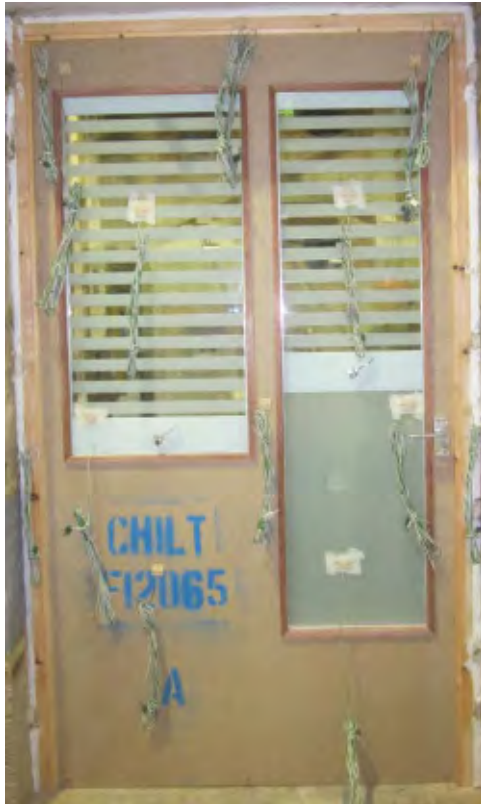
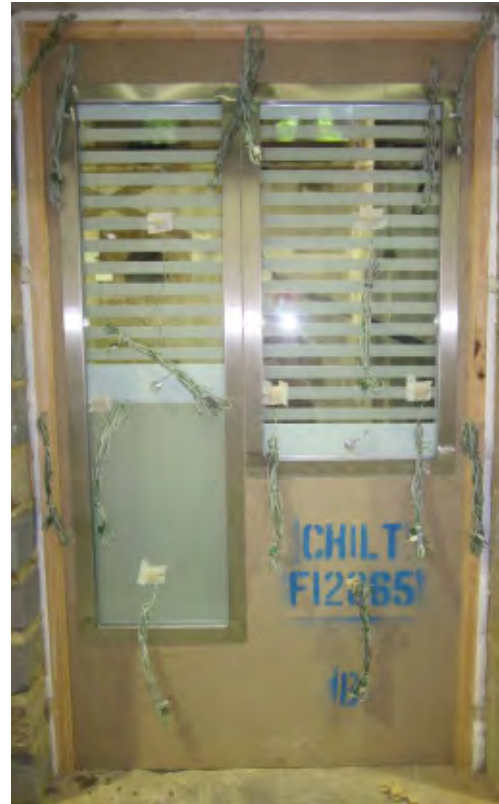
Summary of specimens:

2No Single leaf single acting doorsets both incorporating 2No. glazing panels.

Leaf size – both doorsets: 2100mm high x 1140mm wide x 44mm thick.

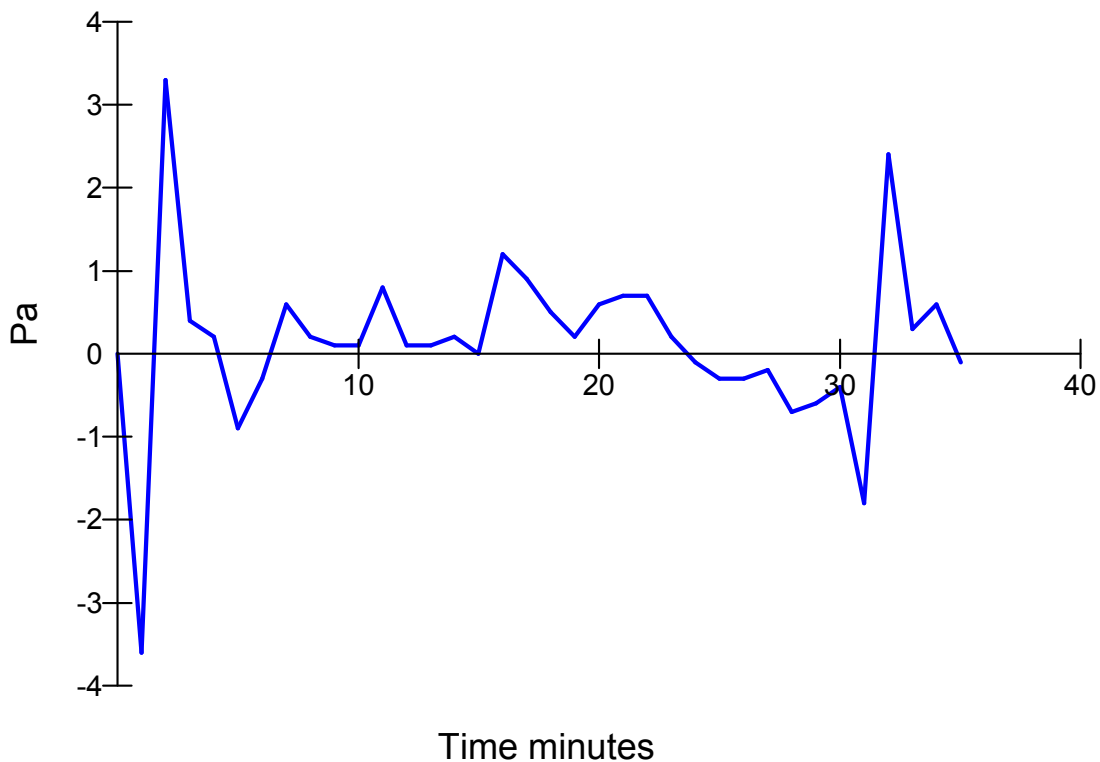
8.2 Pressure readings

After the first 5 minutes of the test, the furnace pressure was maintained at 0 ± 5 Pa and after 10 minutes was maintained at 0 ± 3 Pa with respect to atmosphere, at a point 0.5m from the notional floor level. The pressure readings have been tabulated in Appendix 2 and are shown graphically below:

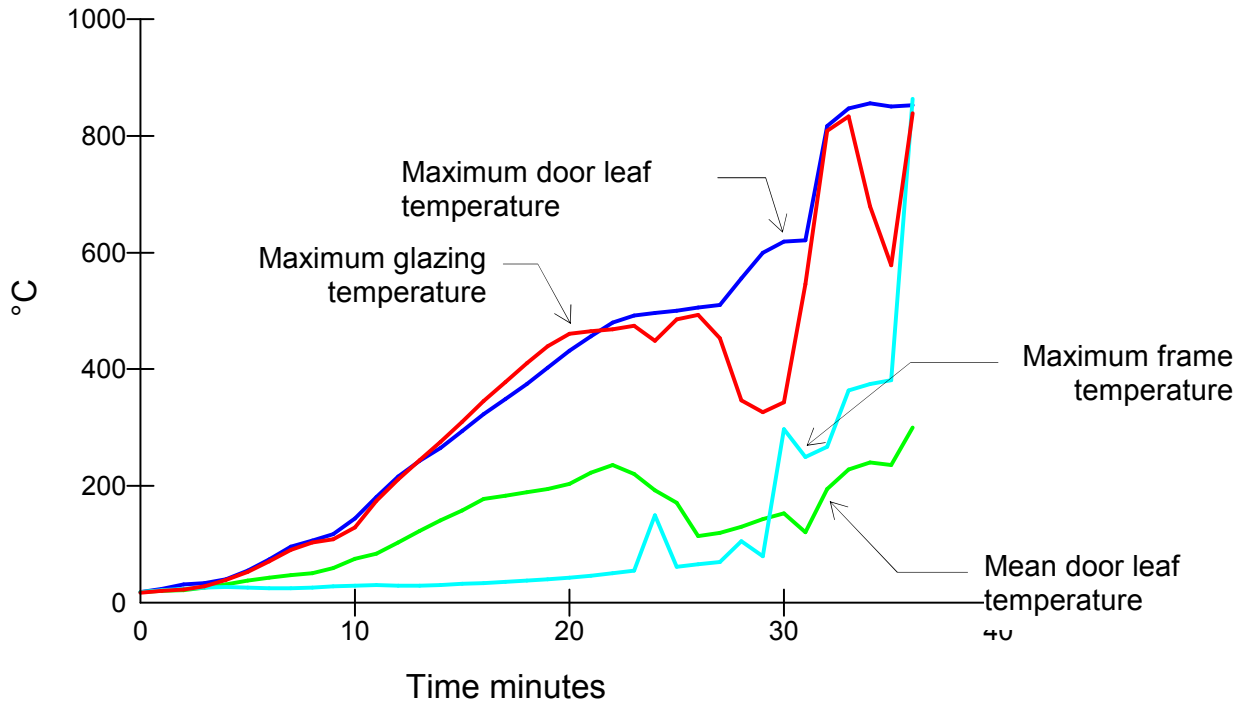
Doorset A

8.4 Unexposed face temperatures

2 discrete areas
Leaf	5 measuring mean temperature rise. 5 measuring maximum temperature rise, standard set 100mm in from the door leaf edges.
Glass	2 measuring maximum temperature rise
Frame	5 measuring maximum temperature rise.

The location of the thermocouples are shown in Figure 6 of Appendix 1. The temperatures recorded have been tabulated in Appendix 2 and are shown graphically below:

Integrity		
Cotton pad		30 (thirty) minutes*
Continuous flaming		30 (thirty) minutes
Gap gauges		31 (thirty one) minutes
Insulation		
	Average set	15 (fifteen) minutes
	Standard set (Max)	10 (ten) minutes
Glass	Maximum	10 (ten) minutes
Door frame	Maximum	29 (twenty nine) minutes
Radiation		30 (thirty) minutes*

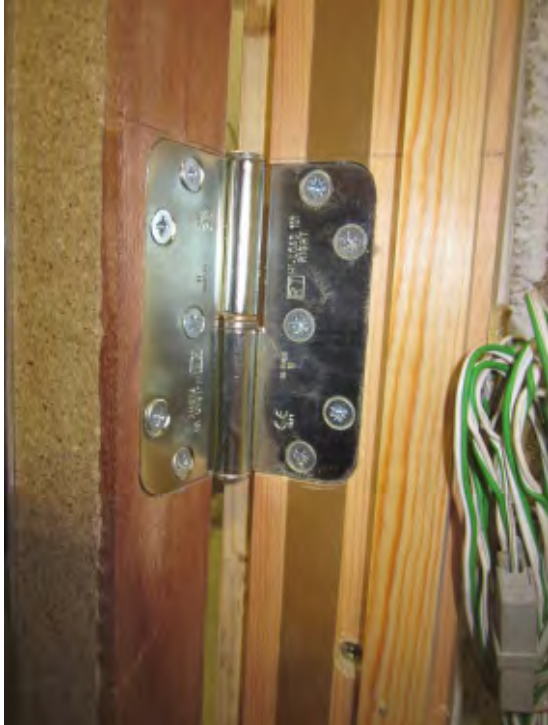
Hinge blade – both doorsets

Make/type	Size (mm)	Location
Around hinges	Fully interrupted	-	Hinge blade fully interrupts seal in frame reveal
Under hinge blade	Interdens	1 thick	Fitted under the hinge blade on the frame and leaf
Encasing latch body	Interdens	1 thick	Fitted around the body of the latch
Under latch forend	Interdens	1 thick	Fitted under the latch forend
Around latch keep	Fully interrupted	-	Latch keep fully interrupts seal in frame reveal
Under latch keep	Interdens	1 thick	Fitted under the latch keep

Intumescent interruptions by hardware

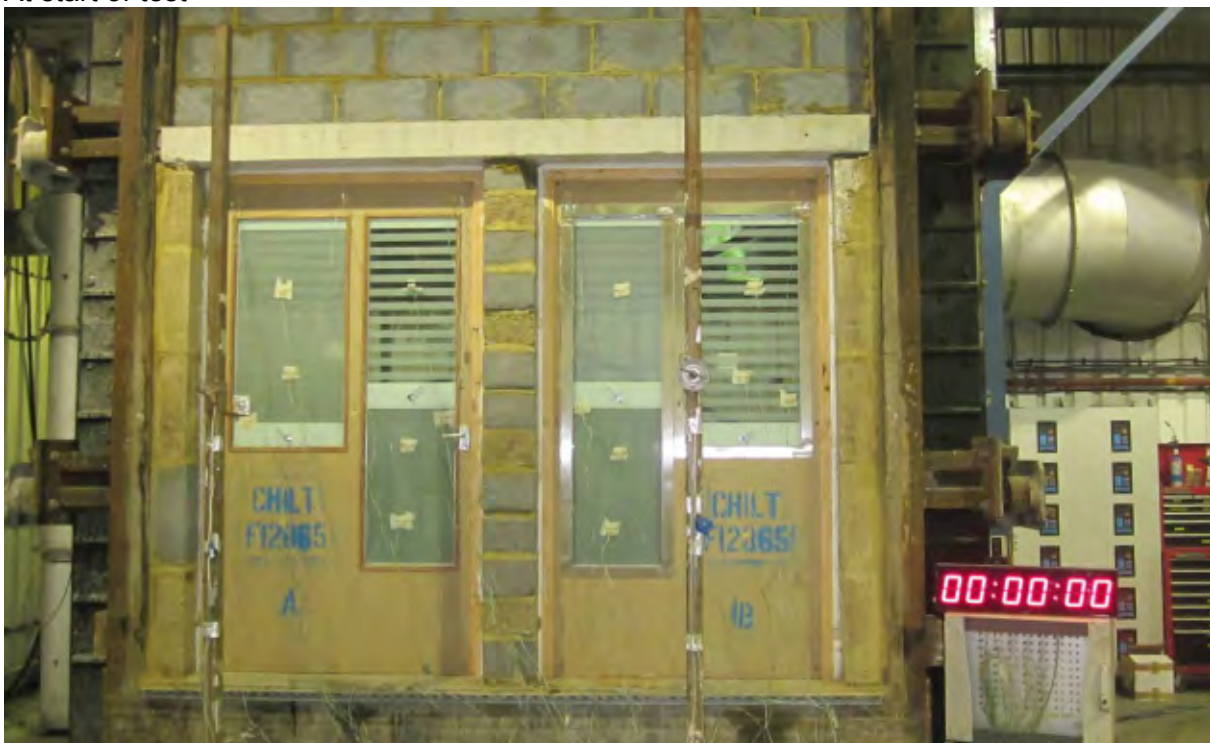
At start of test

Time (minutes)	Comments
00.00	Test started.
01.09	Both doorsets, there is smoke issuing from the top half leaf/frame gaps.
08.00	Both doorsets, the exposed face glazing has cracked across the surface.

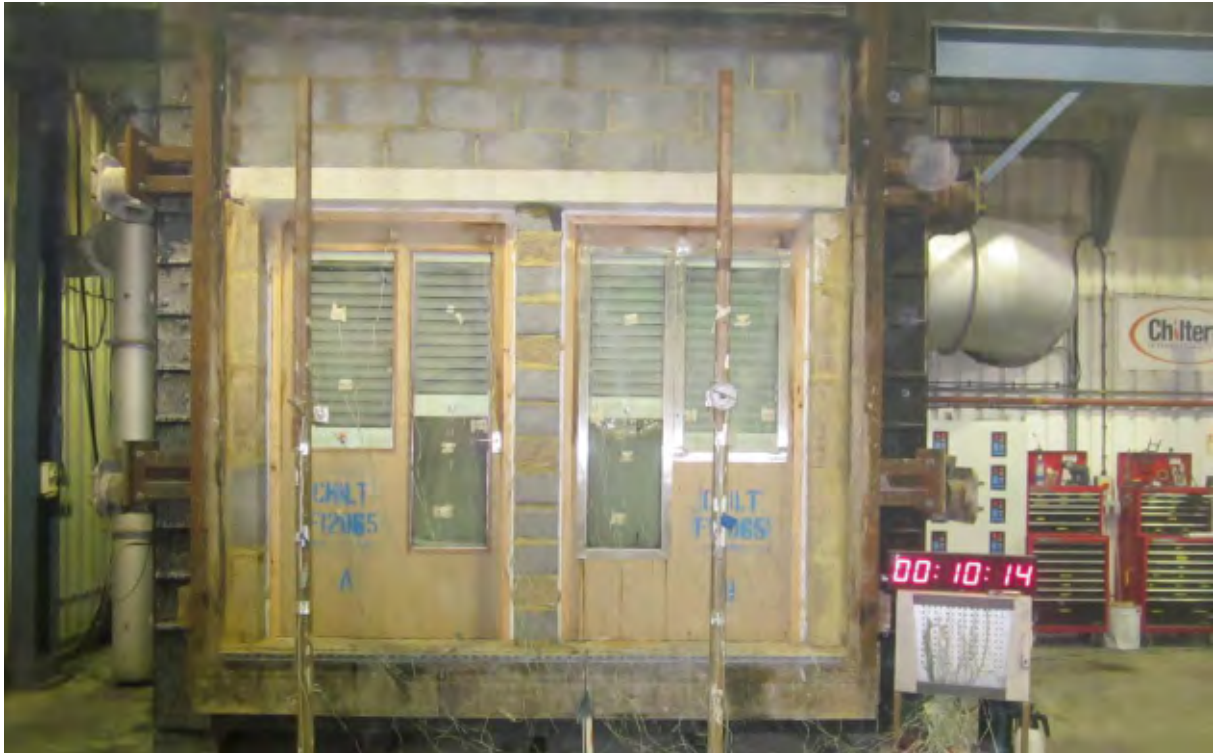
After 10 minutes

10.21	Doorset A, the smoke issuing has reduced to the top hanging corner and the latch position and from the operating lever of the glazed panels.
11.29	Doorset B, the smoke issuing has reduced to the latch position, the top hanging corner, from behind the right panel glazing bead at the top right corner and from the operating lever of the glazed panels.

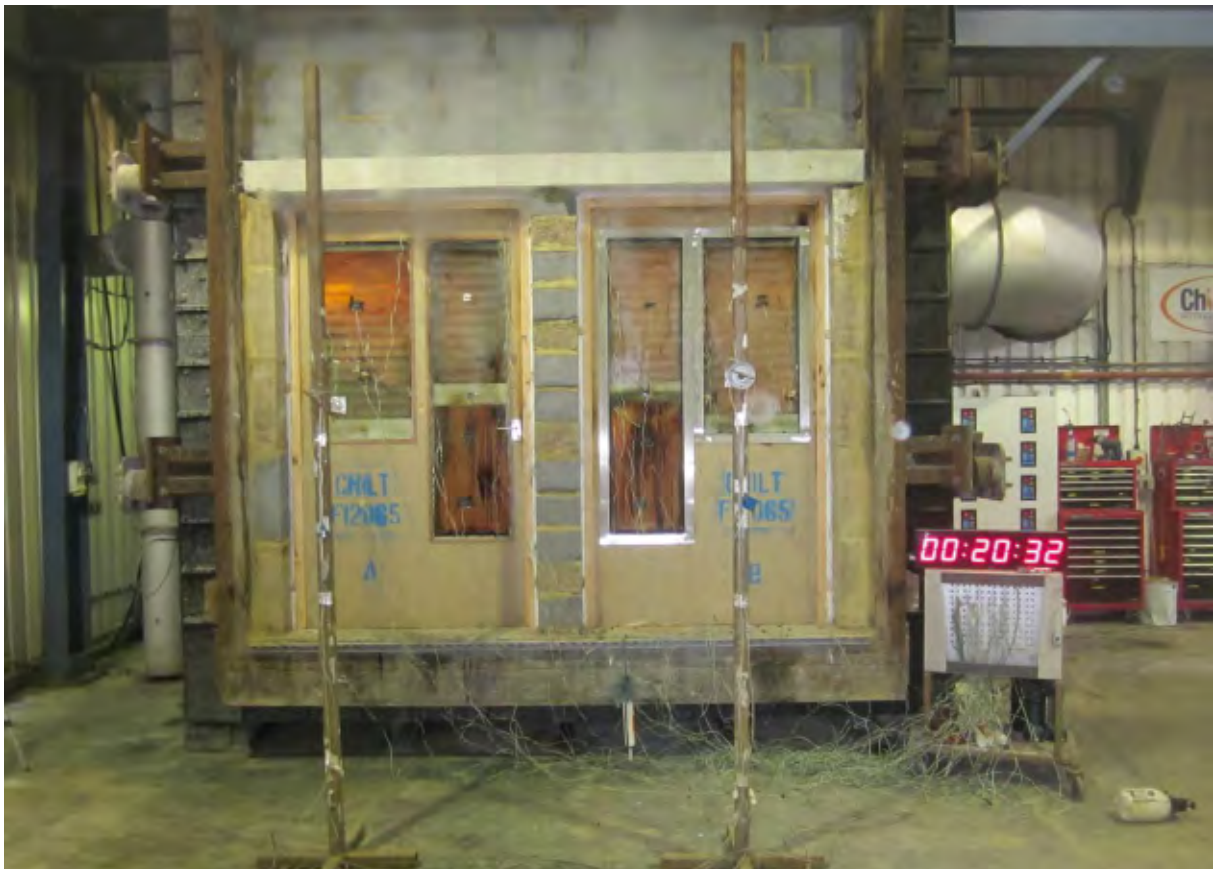
After 20 minutes

12.51	Doorset B, there is discolouration at the top right corner of the right glazed panel glazing bead.
17.25	Doorset A, the left glazing panel exposed face glazing has broken and fallen away. The centre glazing layer has deflected in towards the furnace at the top.

17.30	Doorset A, there is a decrease in the level of smoke issuing from the glazed panel operating levers.
20.15	Doorset A, there is smoke issuing from the perimeter of the glazed panels.

21.21	Doorset B, there is smoke issuing from the perimeter of the glazed panels.
22.40	Doorset A, the top half of the left panel centre glazing layer has fallen away.
